Rupture of a Hydrogel-Filled Breast Implant

Hajo G. Bruining, M.D., and Miklos I. M. Schermer Voest, F.C.S.(Plastic)(S.A.)

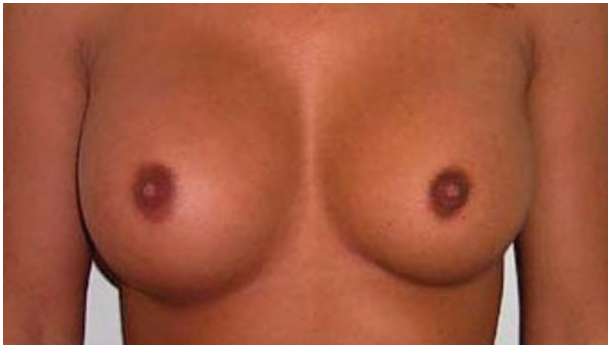
On examination, it seemed that the left breast was of normal size, whereas the right breast had increased in volume (Fig. 1). The left breast was not red or painful. In her right axilla, a round and painful tumor, with a diameter of 1 cm, was noticed. Both breasts felt smooth (Baker I). Her body temperature was normal.

FIG. 1. The right breast is swollen and contains a ruptured hydrogel-filled implant.

Laboratory blood results on liver, kidney, inflammation, and coagulation parameters were all normal. Because to us it seemed clear that the right prosthesis was leaking, we advised our patient to have it replaced. She elected to undergo explantation of both implants and have them replaced with silicone gel-filled prostheses with the same (larger) volume as her right breast.

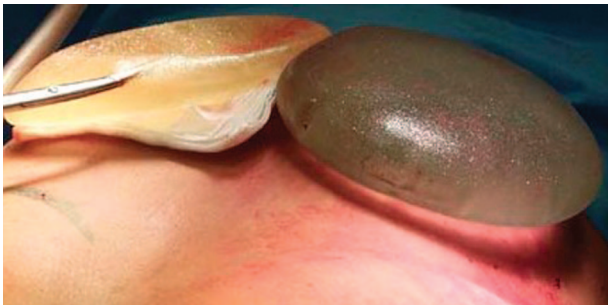
Two days later, she was operated on. On opening the implant cavity of the right breast, we found a seroma-like substance, with a clear, yellowish aspect. The right prosthesis was ruptured on the edge (Figs. 2 and 3). Inspection of the cavities showed no difference in capsule formation between both sides. After rinsing both cavities thoroughly with a povidone-iodine solution, augmentation was performed with two textured silicone gel-filled prostheses. Culture swabs taken during operation revealed no infection. There were no complications after operation (1-year follow-up). The painful tumor in her right axilla disappeared in 2 weeks.

FIG. 2. Point of scissors shows the defect in the ruptured prosthesis.

The possible cause of rupture can be repetitive stress at the site of the envelope, causing

weakening and fracture of the fold.⁸ This is also why the Food and Drug Administration has set a “fatigue testing protocol” to be predictive of clinical failure for breast implants.⁹

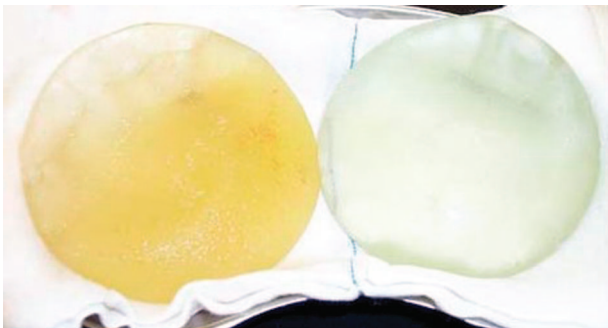
FIG. 3. Yellowish (ruptured) right breast prosthesis.

Hydrogel breast implants consist of a silicone elastomer shell containing hydrogel filler. Hydrogels are polymeric materials that have the ability to swell in water without dissolving and retain water within their structures.⁷ This explains the swelling of the breast containing the leaking implant. Swelling of the lymph node, as presented in this case, is possibly caused by staining of carboxyl methyl cellulose in the lymph node and its hydrophilic characteristic. Another hypothesis is that swelling is caused by an inflammatory reaction.
